GENERAL INFORMATION:

Client Name	:			
Supplier	:		Factory	:
Inspection Date	:		Location	: HUAIAN, CHINA
Inspector(s) Code	:			
Authorizer	:			
Inspection Type	:	Pre-Shipment Inspection		
Product Description	:	ELECTRIC KETTLE		
Purchase Order No.	:			
Item/SKU/Style No.	:	153185, 153186		
P.O. Quantity	:	8872 Pieces		
Shipment Quantity	:	8872 Pieces

INSPECTION RESULT SUMMARY:

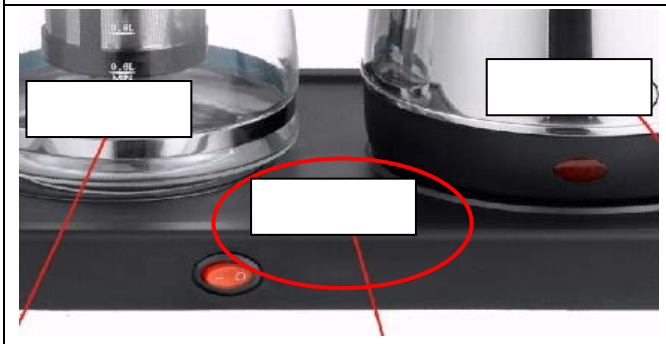
Photo provided by client	Actual found

2) For item 153185, discrepancies were found between digital photo provided by client and actual found:

logo on top of the plate	Logo was on one side of plate
3)	For item 153185, logo size was 44x13mm instead of 40x10.362mm required by client.	
4)	No CDF was provided by factory for checking during inspection.

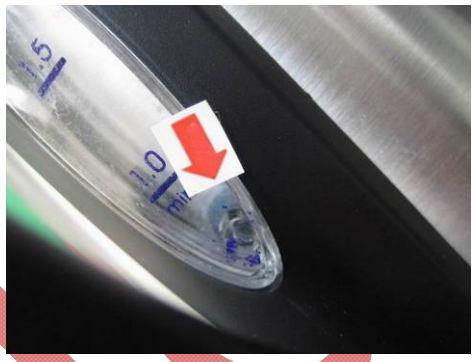
No.	**Defects Description:**	**CRI**	**MAJ**	**MIN**
Item No.: 153185	**Sample Size: 49 Samples**			
1.	Dirty mark on surface	-	-	1
Item No.: 153186	**Sample Size: 151 Samples**			
2.	Scratch mark on surface	-	-	2
3.	Extra painting on water level	-	-	1

dirty mark on surface(mi)

slightly scratch mark on surface 1(mi)

extra painting on water level(mi)

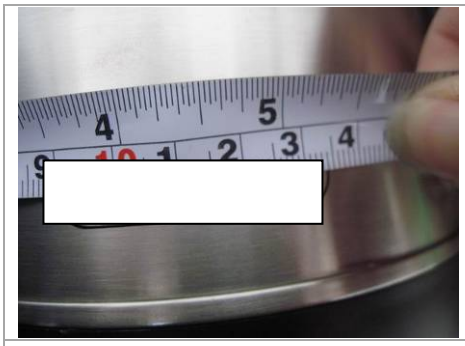
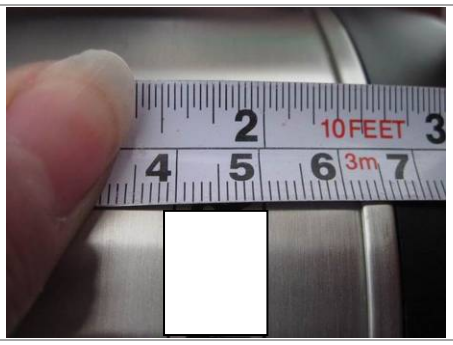
Item	Sample size	Check points	Spec	Actual
153185	2pcs	Capacity	1.5L	1.6L, 1.7 L
		Body size	-	Tea set:185x130x140 cm Plate:41.7x20.5x3 cm Kettle:212x160x220 cm
		The length of power cord	-	99cm
		Rating label size	40x22mm	40x22mm
		Logo size on tea set	35x9.066mm	35x9mm
		Logo size on warm plate	45x11.565mm	45x12mm
		Logo size on Kettle	45x11.656mm	45x12mm
		Unit weight	-	Tea set: 350, 354, 353 Plate:672, 678, 672 Kettle:690, 682, 680 Power cord:136, 136, 135
153186	2pcs	Body size	-	220xx168x218mm
		The length of power cord	-	70cm
		Rating label size	40x22mm	40x22mm
		Logo size	40x10.362mm	**44x13mm**
		Unit weight	-	914, 910, 918

P204) logo size 1	***P205) logo size 2***	***P206) defect-slightly scratch mark on surface 1(mi)***

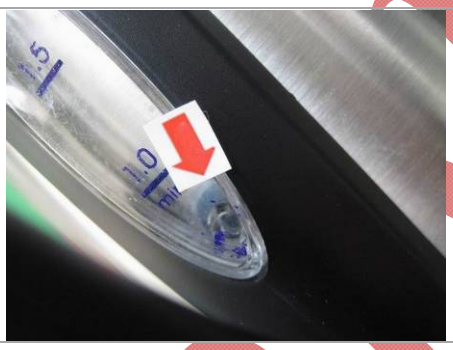
***N/A***
P207) defect-slightly scratch mark on surface 2(mi)	***P208) defect-extra painting on water level(mi)***	***N/A***
